APOLLO 16 MISSION

ANOMALY REPORT NO. 10

REAR STEERING INOPERATIVE

NATIONAL AERONAUTICS AND SPACE ADMINISTRATION  
MANNED SPACECRAFT CENTER  
HOUSTON, TEXAS  
January 1973

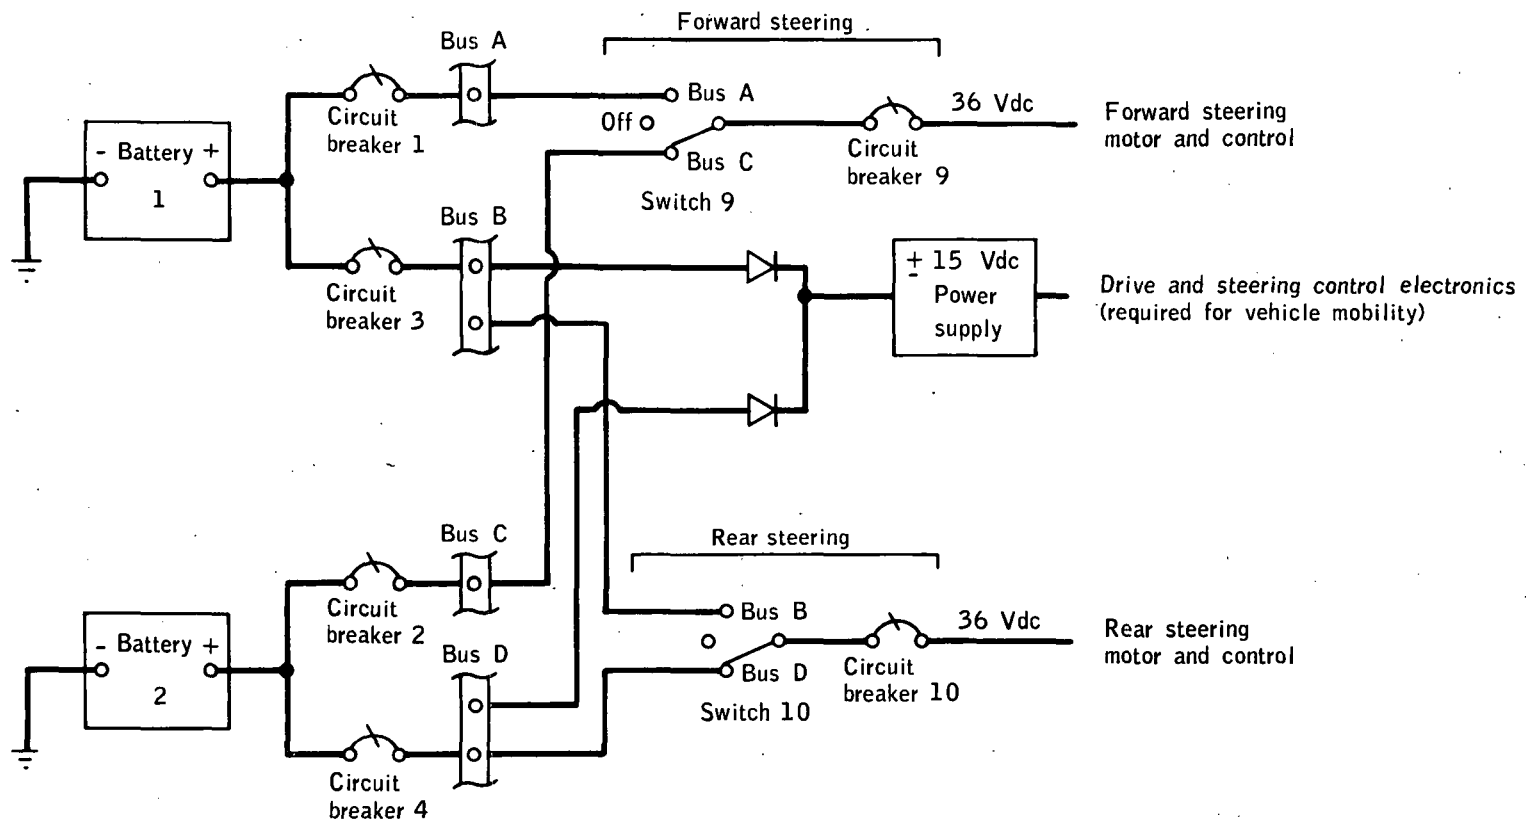
Figure 1.- Lunar roving vehicle steering power schematic.

Both the front and rear wheels of the lunar roving vehicle are steerable and are controlled by a hand controller. The driver can select front, rear, or both front and rear steering using switches located on the control and display panel. The rear steering system is powered when either circuit breaker 3 or 4 is closed, and circuit breaker 10 is closed with switch 10 positioned to the active bus (fig. 1).

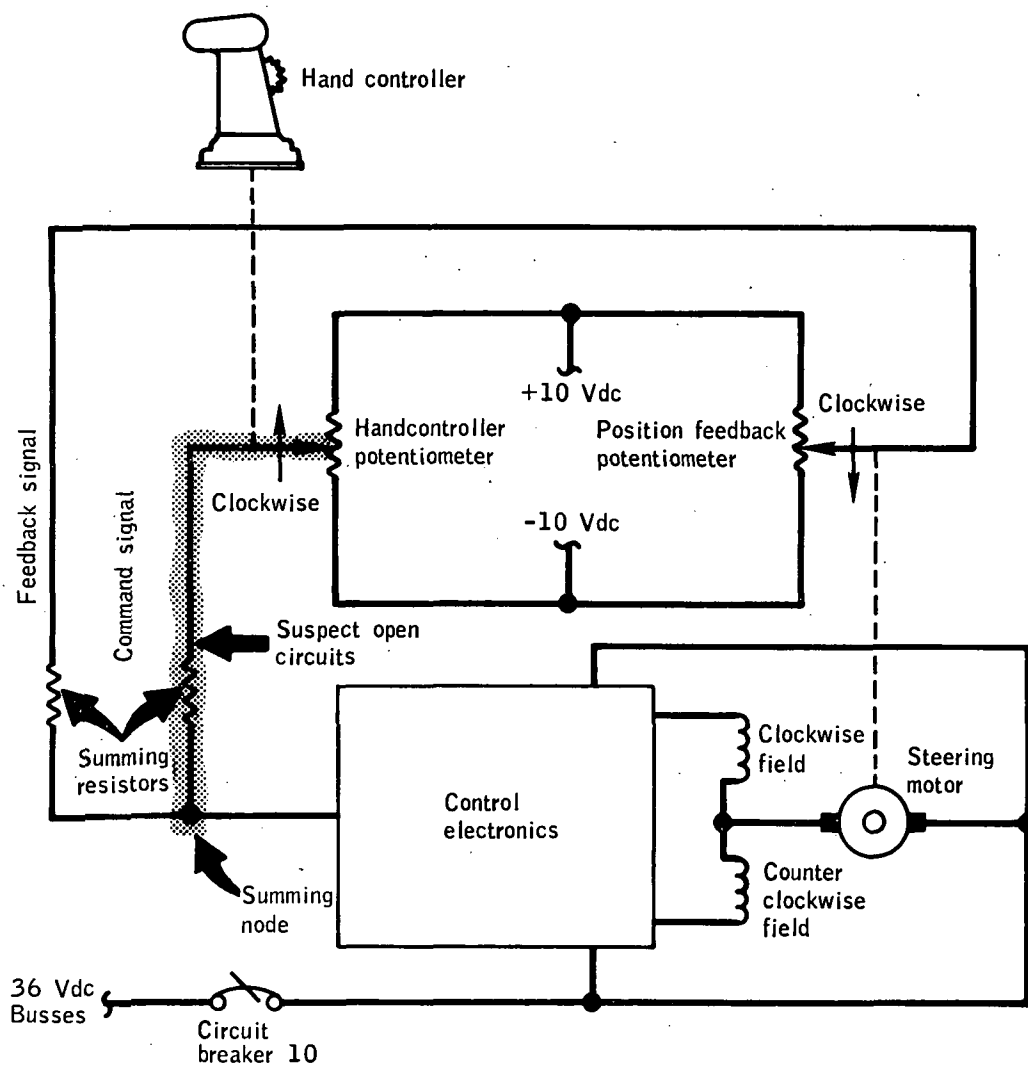
Figure 2.- Electrical steering system.

When the hand controller is positioned for a right turn, the hand controller potentiometer wiper is moved toward the positive end of the resistive element. The wiper voltage will increase (become more positive) as shown in figure 2. The summing node voltage will also increase, causing the control electronics to drive the steering motor clockwise until the wiper voltage from the position feedback potentiometer is equal but opposite in polarity to the hand controller potentiometer wiper voltage. At this point, the summing node voltage will be zero (the two voltages are added at the summing node) and the steering motor will stop. A similar sequence occurs for a left turn.

The only condition that will cause loss of steering and still keep the wheels centered during turns is an open circuit, either in the hand controller potentiometer or in the wiring between the potentiometer wiper and summing node (fig. 2).

The wiring, connectors, and summing resistor are all adequate. The only problem found was that the potentiometer wiper would open-circuit at temperatures below minus 58° C because the lubricant used in the potentiometer congealed. Thermal analysis, however, showed that neither lunar roving vehicle 1 or 2 reached temperatures below minus 5° C.

An open circuit must have occurred either in the hand controller potentiometer or between the potentiometer wiper and the summing node.

No corrective action was taken since the problem could not be further isolated and since the vehicle design and testing were considered adequate.
